Engineered Composite Repair Solutions Overview

Seamless Restoration: Efficient Repairs Beneath a Helideck

Structural repair of bridge link beams in the Dutch North Sea

DRS Pipe Deck Repair

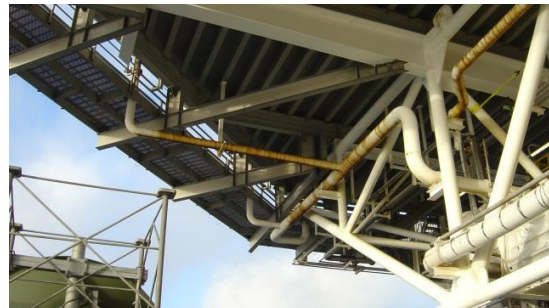
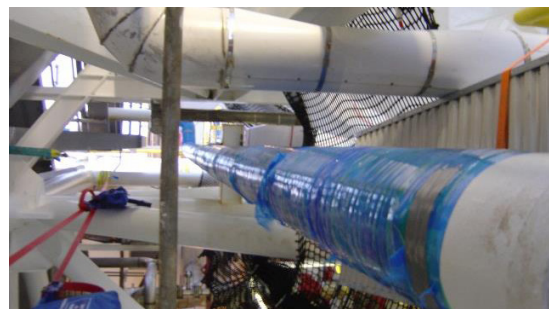
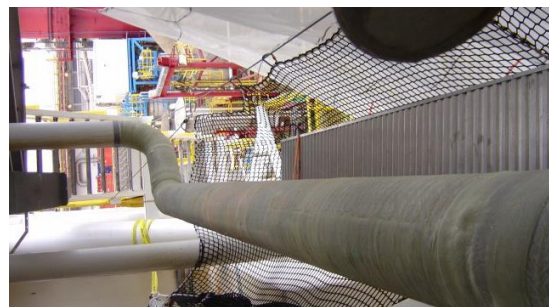
Our client faced a critical challenge as various sections of pipework beneath the helideck had suffered severe corrosion, resulting in wall thinning that fell below the maximum allowable thickness. As the pipework was located under the helideck, any repairs had to avoid causing any shutdowns, prompting the choice of an engineered composite composite solution, Technowrap. The project's scope aimed to deliver an engineered design with a 20-year repair lifetime, along with Technowrap™ trained personnel and Technowrap™ 2K materials to complete the repair. The line's design temperature was set at 90°C.

After a thorough review of inspection reports and process operating information, it was determined that an engineered composite solution could restore the line's integrity while allowing the repairs to proceed without platform downtime or shutdown. Given the challenging location underneath the helideck, access presented a significant issue for our client in terms of both cost and operational impact. To mitigate the need for extensive scaffolding, multi-skilled rope access-trained composite repair technicians were deployed to implement the repairs. Comprehensive risk assessments were conducted to minimise potential risks associated with the work. Achieving excellent adhesion between the pipe work substrate and the Technowrap™ 2K repair was critical, necessitating surface preparation to SA 2.5 standards.

The project was executed successfully on time and budget, and most importantly, with no incidents or accidents. The mobilisation of rope access technicians for the repairs eliminated the need for extensive scaffolding, resulting in substantial cost savings and no disruption to platform operation. The repair was completed efficiently, with no shutdown or downtime required, and the solution was designed to provide a 20-year lifetime, ensuring long-term integrity for the pipework beneath the helideck. This case study highlights our ability to provide efficient and effective solutions, even in challenging locations, while prioritizing safety and minimizing operational impact.

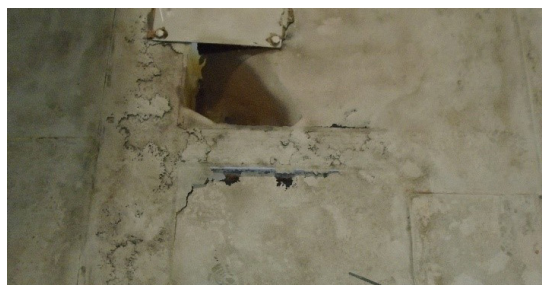
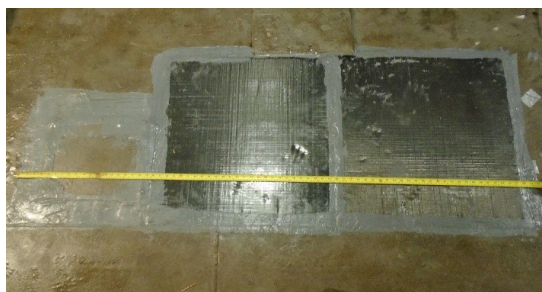
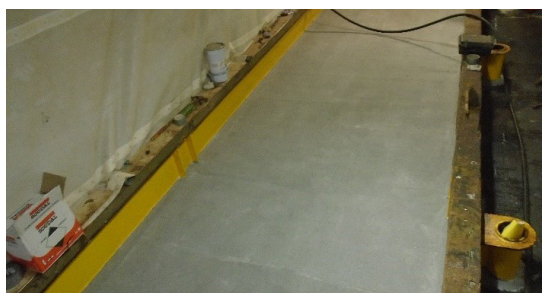
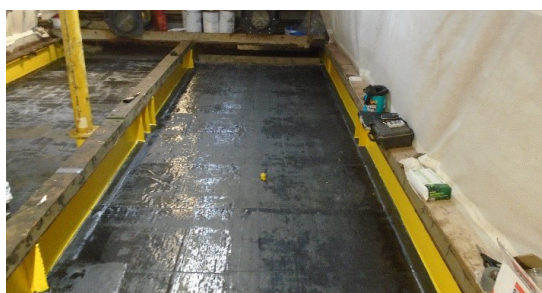
Two large laydown areas onboard an operator's asset offshore in the North Sea were suffering from external corrosion and multiple through wall defects resulting in water ingress. As the roof was classified as a laydown areas and subjected to personnel traffic there was a requirement that the load capacity of the roof was factored into the design. This unique design ensured that the laminate could withstand the applied loads and impacts associated of +5kN/m².

ICR provided an engineered design using four layers of Technowrap™ DRS. Combining the properties of the Technowrap™ SRS (Structural Rehabilitation System) carbon fibre and DRS a rubber toughened epoxy resin system. Our integrated approach, providing engineering, materials, technician training and installation, all in-house, has enabled ICR to become an industry specialist. Third party training for the contractor on application and QA/QC procedures was provided and the contractor was subsequently supervised by a ICR technician.
